**STATE OF HAWAII
DEPARTMENT OF LAND AND NATURAL RESOURCES
ENGINEERING DIVISION
DAM SAFETY PROGRAM
Honolulu, Hawaii**

Regarding: Dam Safety Enforcement Action on Keaiwa Reservoir (HA-0049)
for Failure to Comply with Notice of Deficiency, February 18, 2020

Dam Owner: Edmund C. Olson Trust No. II (Edmund C. Olson, Trustee)
P.O. Box 280
Pahala, HI 96777

Location: Middle & Lower Moaula Camp, Pahala, Hawaii County
Tax Map Key: (3) 9-6-007:001, (3) 9-6-007:002

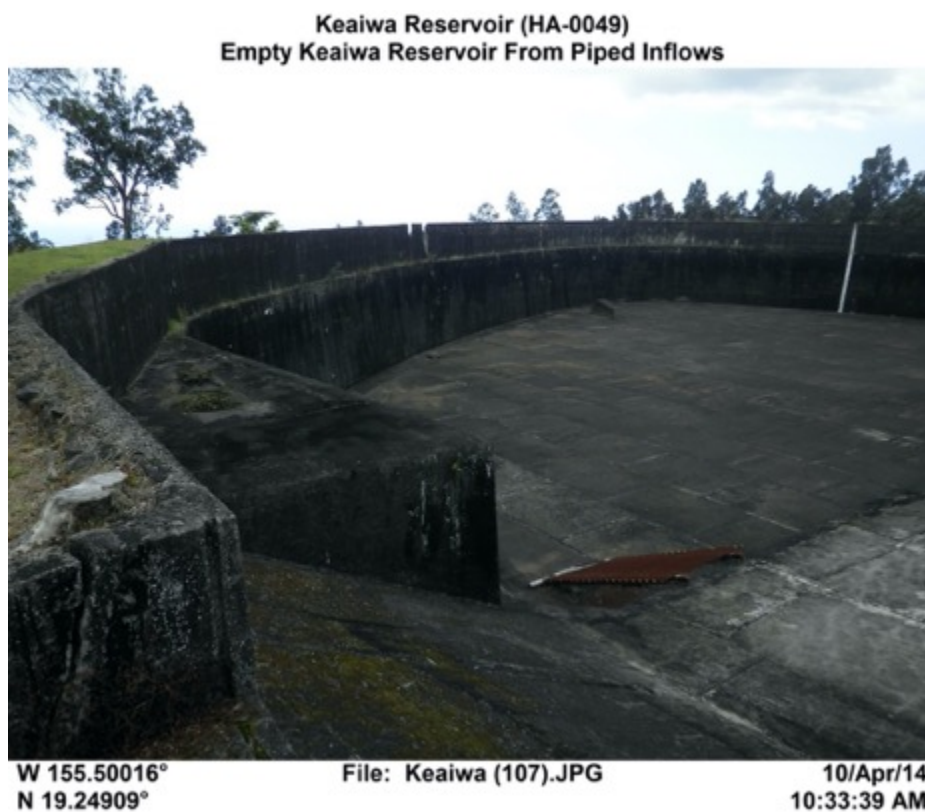
Figure 4. Keaiwa Reservoir upstream embankment from NE embankment (April 2014).

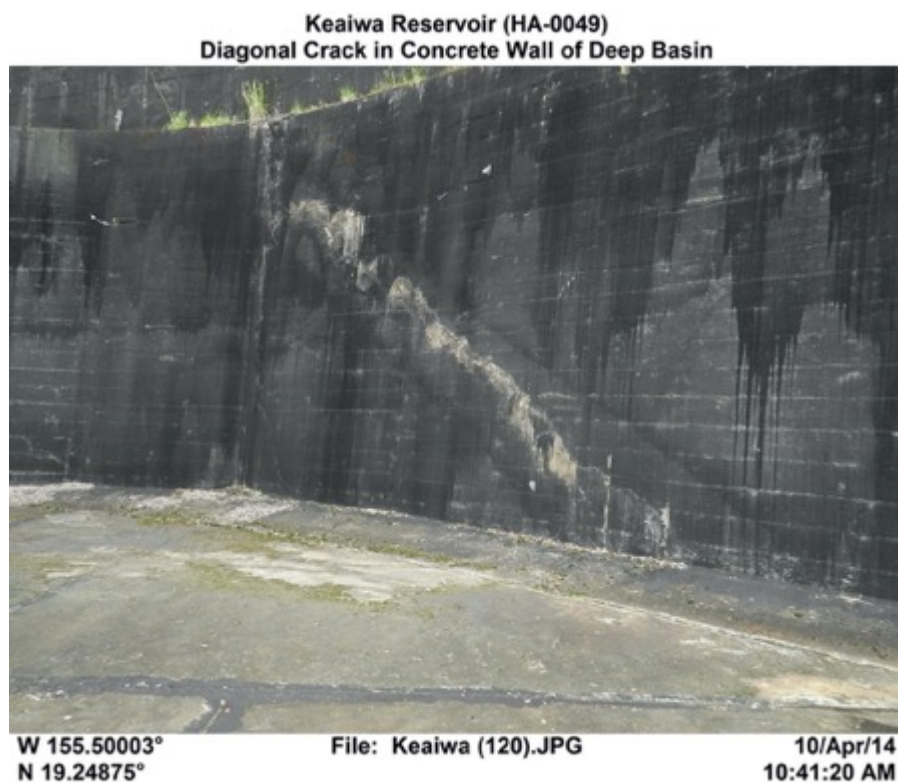
Figure 7. Keaiwa Reservoir eastern embankment concrete lining cracking (April 2014).

The principle area of concern with the concrete lining was the eastern embankment lining (Photo 4). The lining was damaged during a 1975 earthquake. The damage included movement of the wall from vertical to 13 degrees over vertical, and tension cracks were visible in the concrete support columns. Remediation efforts were completed on the wall by installing a deadman type anchor system into the wall and embankment in 2009 and 2010. As part of the remediation efforts to install the deadman anchor system, a significant portion of the eastern embankment was excavated and not backfilled upon completion. This work was completed without permitting or DLNR notification. The embankment that was excavated to place the deadman anchors should be rebuilt to the crest of the concrete lining. Additional repairs, such as filling in the missing concrete and cracking in the concrete lining, should also be completed to ensure the structural integrity of the lining.

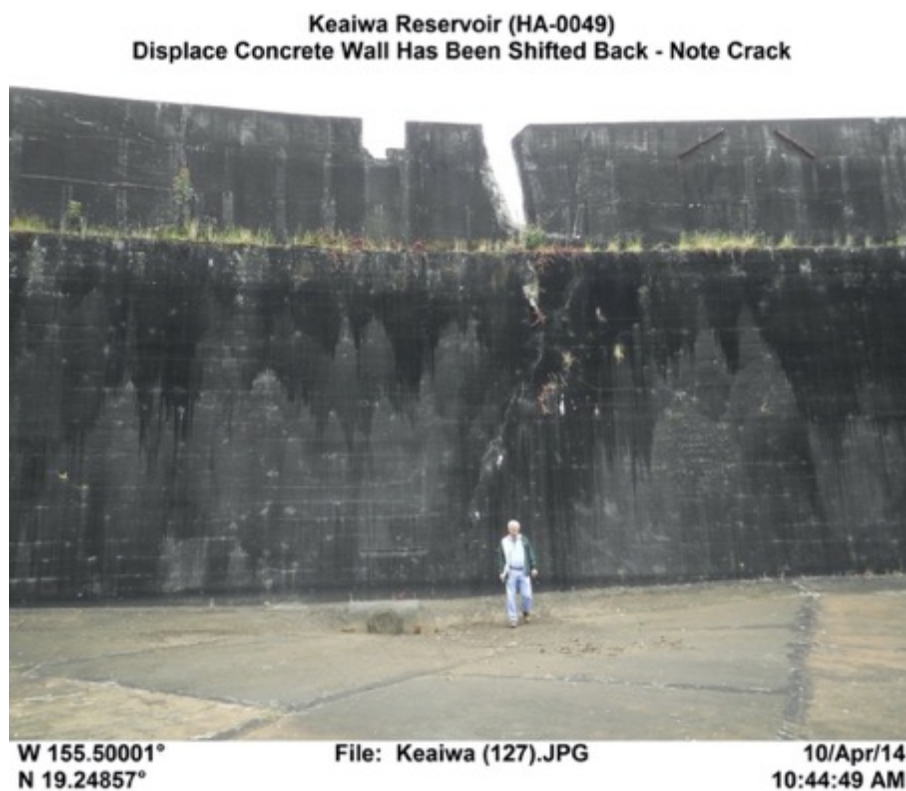
Figure 8. Keaiwa Reservoir embankment concrete lining cracking (April 2014).

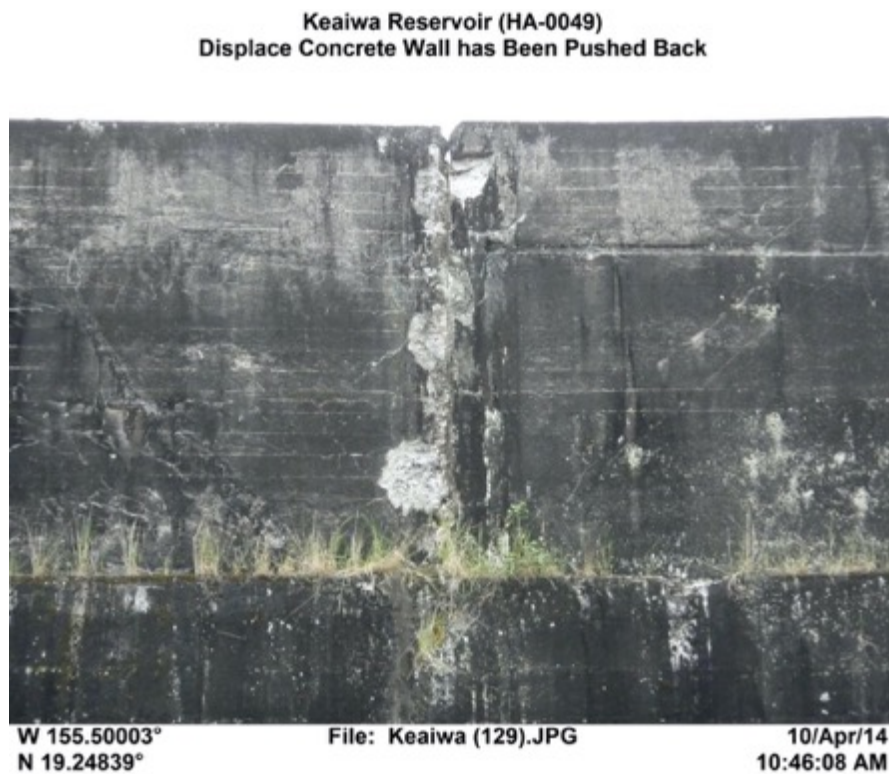
Figure 9. Keaiwa Reservoir concrete lining cracking and displacement (April 2014).

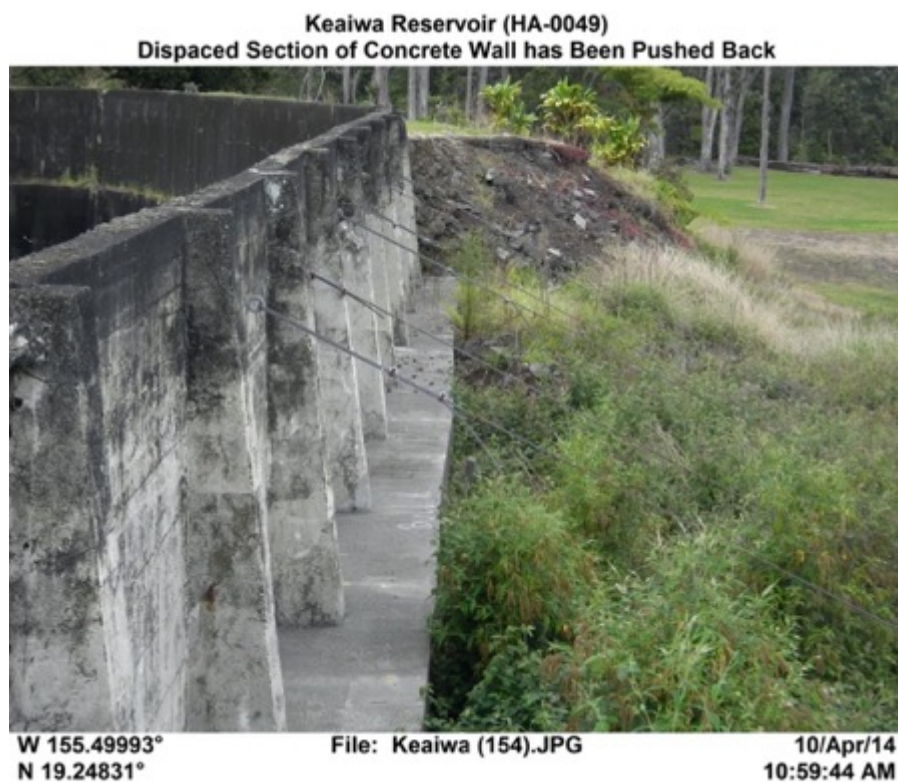
Figure 10. Keaiwa Reservoir concrete wall with deadman anchors (April 2014).

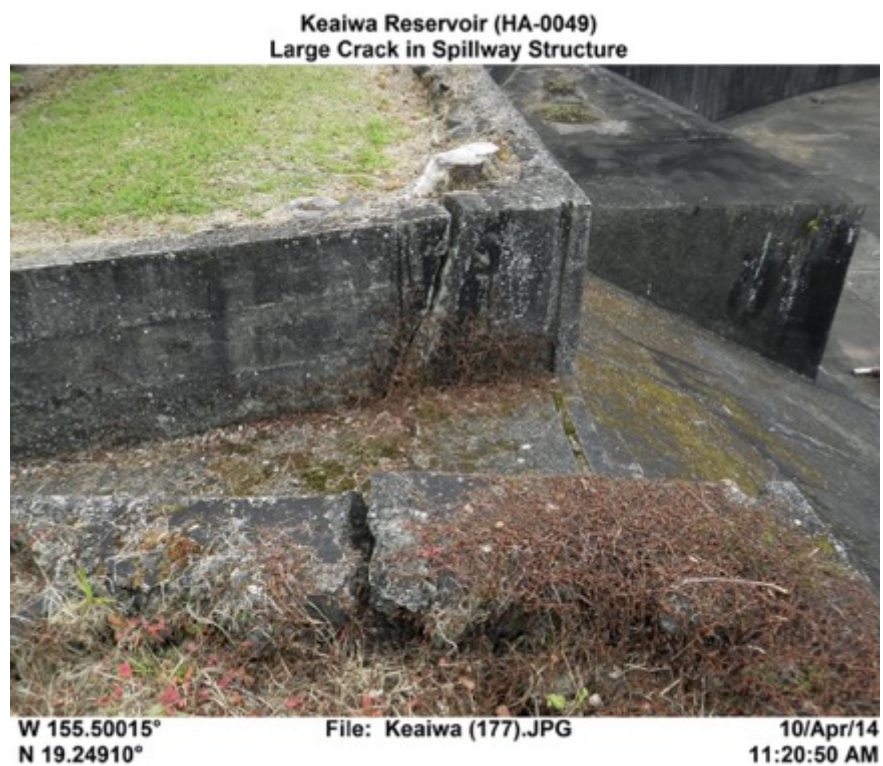
Figure 11. Keaiwa Reservoir cracks in spillway channel (April 2014).

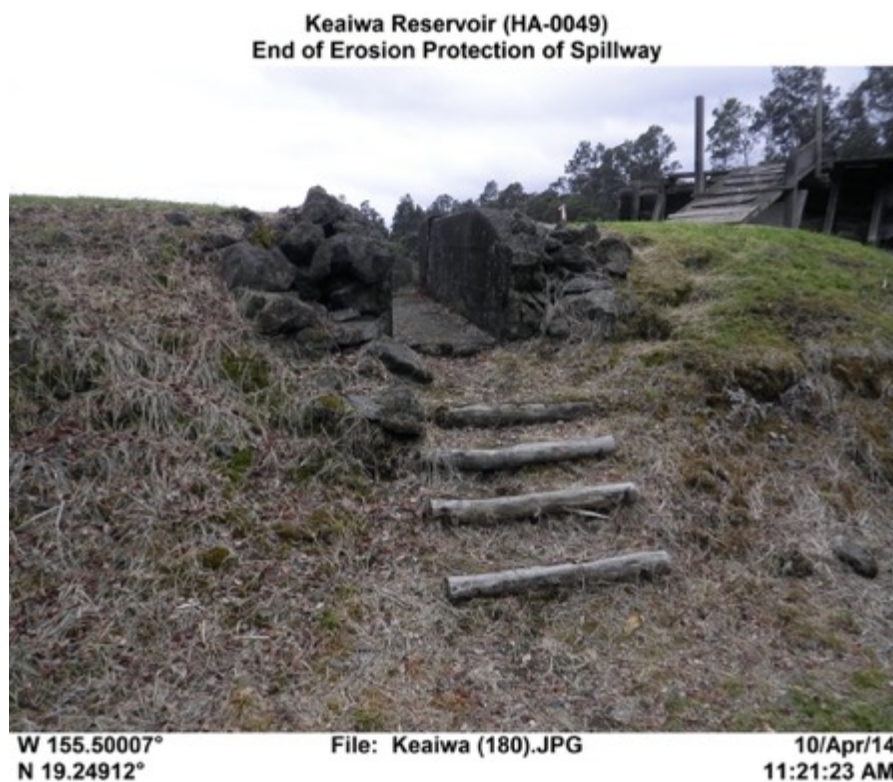
Figure 12. Keaiwa Reservoir erosion at downstream of spillway (April 2014).

There was no clearly defined downstream channel for the northeast embankment spillway. Flows from the embankment could result in erosion along the embankment toe and downstream slope if left in current condition. Natural topography downstream of the spillway will likely direct flows into the Ka'ala'ala Gulch.

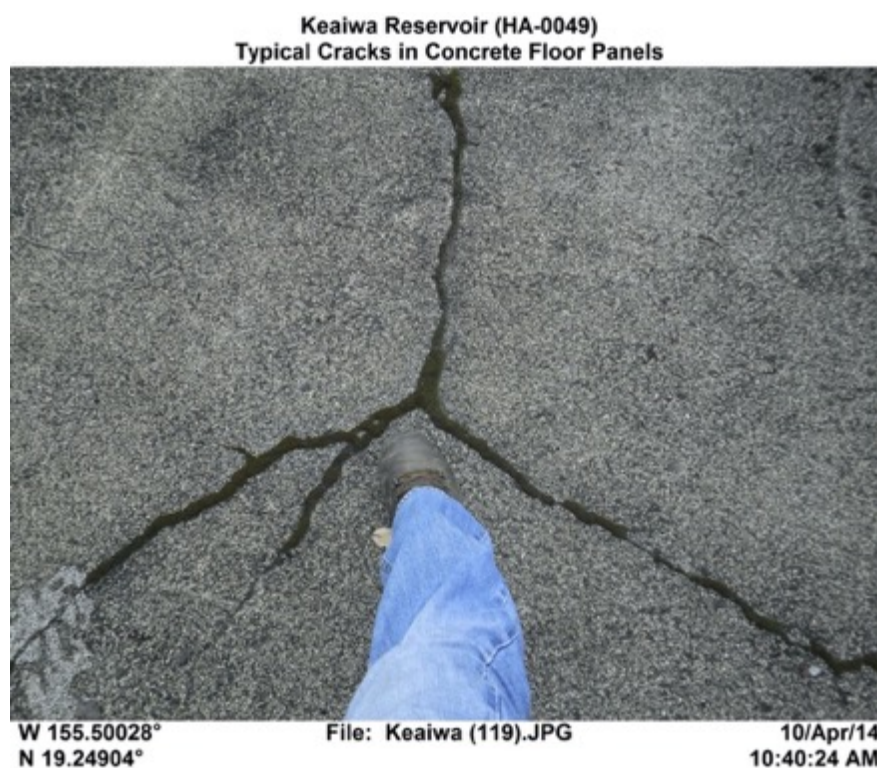
Figure 13. Keaiwa Reservoir typical concrete floor panel cracking (April 2014).

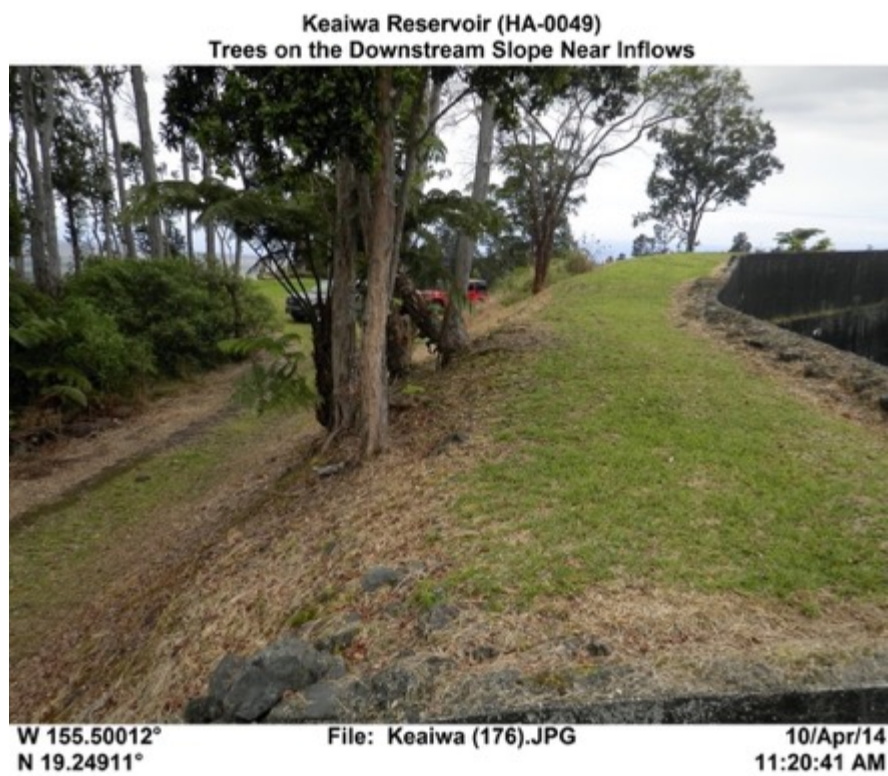
Figure 15. Keaiwa Reservoir typical trees growing out of downstream slope (April 2014).

and 10). As the stumps and roots continue to decay and rot, they can potentially create voids and potential seepage pathways within the embankment and increase the potential for internal erosion to initiate, if the reservoir were to fill again. The trees, stumps, and roots along the embankment upstream and downstream slopes should be removed following guidance provided in the 2005 FEMA Technical Manual for Dam Owners, Impacts of Plants on Earthen Dams.
